## Energy attenuation performance of impact protection worn by motorcyclists in real-world crashes

Bianca Albanese<sup>a</sup>, Tom Gibson<sup>b</sup>, Tom Whyte<sup>b</sup>, Lauren Meredith<sup>a</sup>, Giovanni Savino<sup>c</sup>, Liz de Rome<sup>d</sup>, Matthew Baldock<sup>e</sup>, Michael Fitzharris<sup>f</sup>, and Julie Brown<sup>a,g</sup>

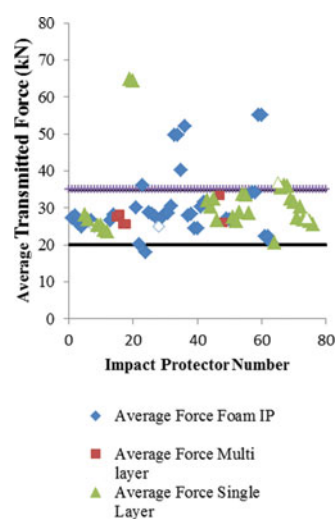
**Figure 1.** Average transmitted force recorded from the IP collected from the crashed riders. Unfilled shapes denote the presence of an impact injury.

Eighty-three percent of the 76 IPs collected passed the Level 1 (Table 2) and 1% passed the Level 2 energy attenuation requirements of EN 1621-1. Average transmitted force and maximum transmitted force measured during testing are presented in Figures 1 and 2, respectively. These figures also graphically represent the average and maximum transmitted force by IP of different construction, as well as the results with respect to the energy attenuation requirements of EN 1621-1.

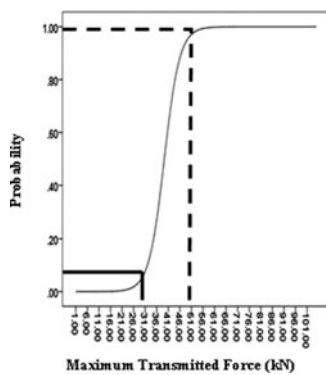
**Figure 4.** Probability of injury by maximum transmitted force. Dashed and solid lines denote Level 1 and Level 2 performance limits as specified in EN1621-1:2012.

0.896–1.014) when controlling for rider age, weight, and vehicle impact speed via regression modeling. Additionally, there was no association between the average force transferred through an impact protector and the presence of an impact injury (95% CI: 0.91–1.24); however, as maximum force transmitted increased, impact injury was more likely (OR = 1.1, 95% CI: 1.01–1.2). As shown in Figure 4, the probability of injury was high at the maximum transmitted force allowed by Level 1 EN 1621-1.
